**PROGRESS REPORT
TO
OFFICE OF NAVAL RESEARCH**

TITLE: Development of an Expendable Particle Sensor

DATE: 22 February 1994

This report addresses progress on the Development of the Airborne and Ship Deployable Expendable Particle Sensor, A&XOTD from 2/93 to 2/94.

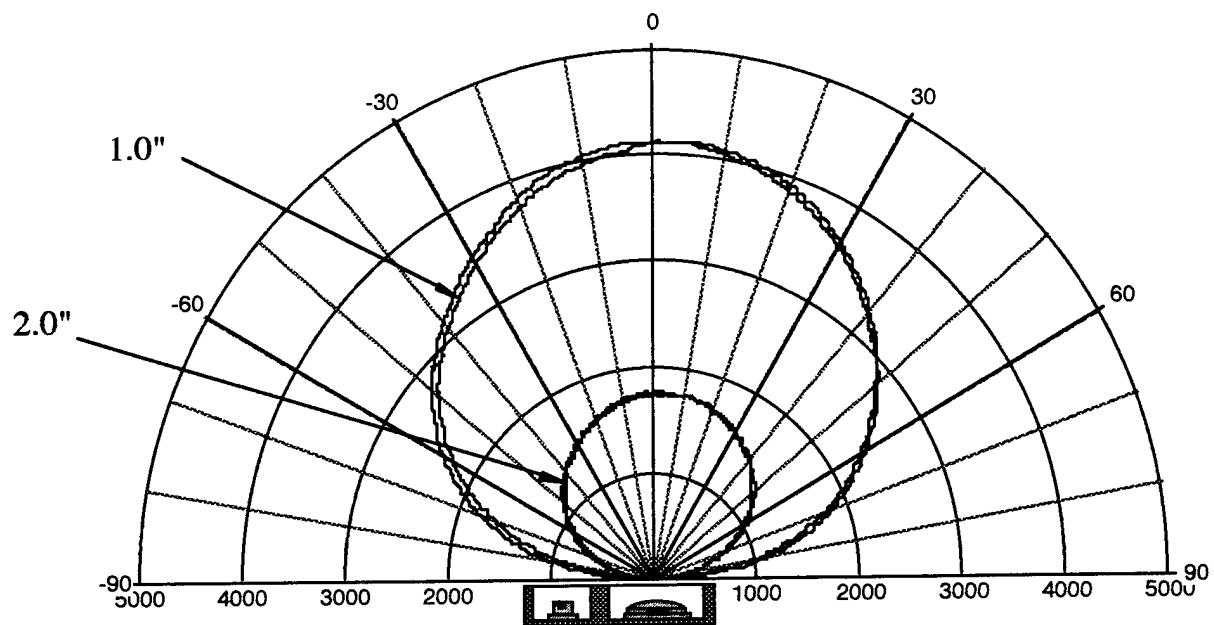
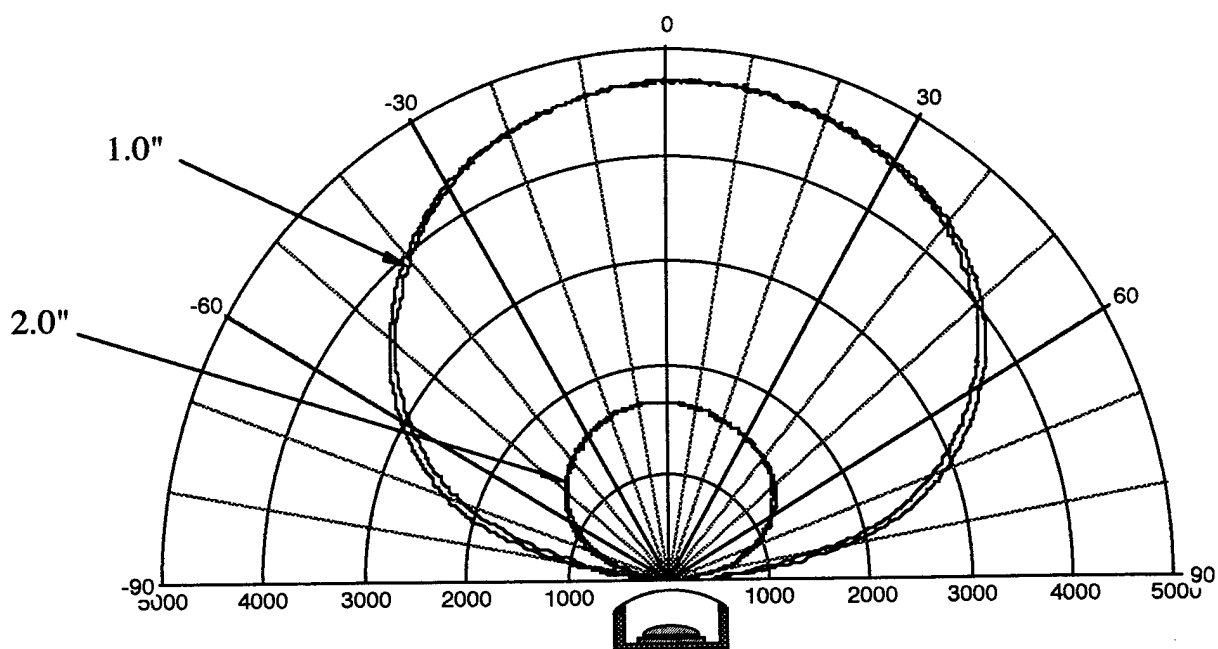
Figure 1 and figure 2 show the LSS radiance and irradiance distribution in water. Sensor orientation is shown since the beam is not symmetrical. The double peak in the light beam results from two LED's spaced some distance apart and as expected the light detector has nearly a cosine response.

Figure 3 Expendable Scattering Sensor Detector Irradiation Pattern in Water
